Building Conditions Survey for The Bradley Palmer Mansion

at Bradley Palmer State Park
Topsfield, Massachusetts

Prepared by
Ocmulgee Associates Consulting Structural Engineering
and
Robert Carlson
for
Commonwealth of Massachusetts
Department of Environmental Management
Historic Curatorship Program
August 1995

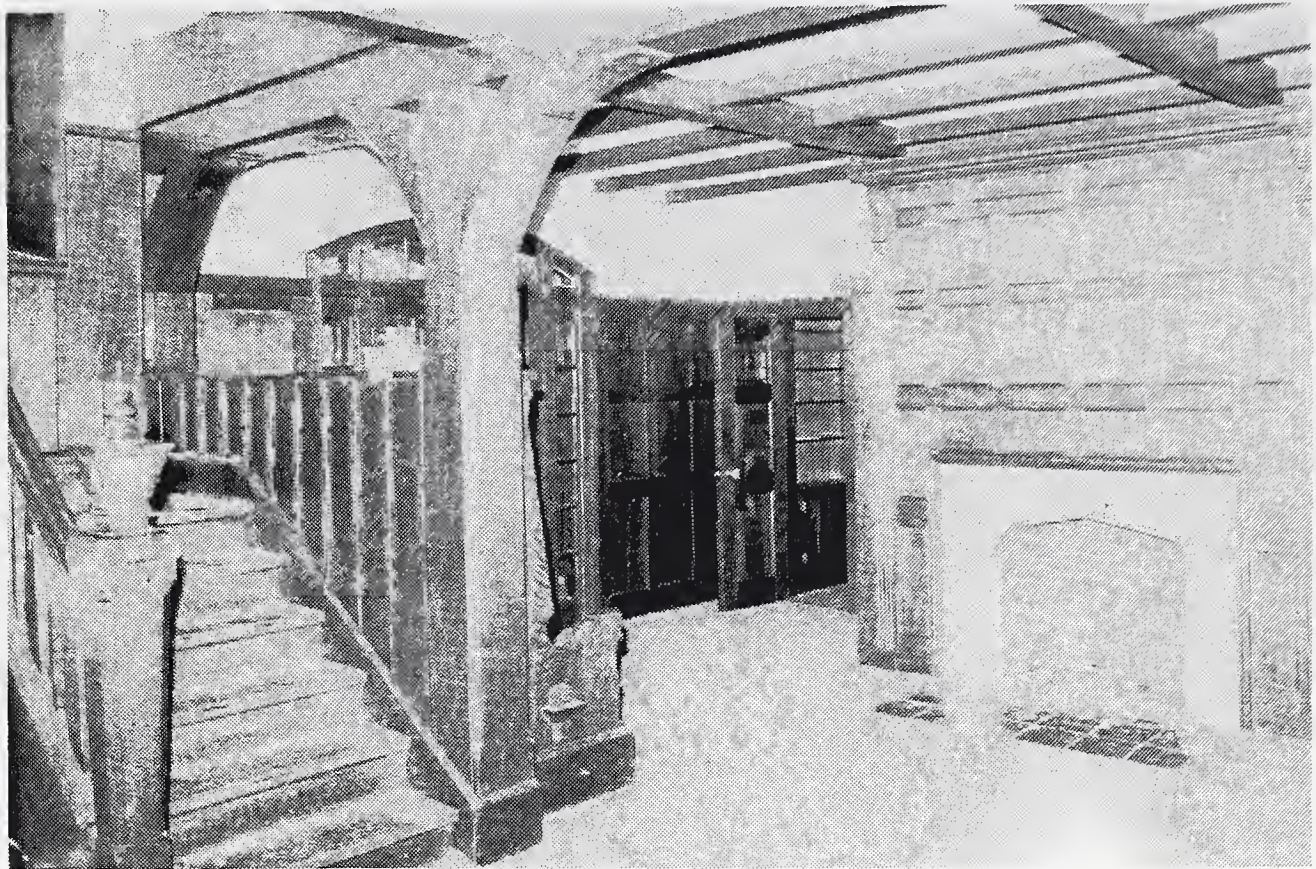
The first floor living areas are distinguished by oak paneling and limestone fireplaces (Figure 2); the dining room has a tile floor, decorated limestone fireplace and windows evocative of a medieval theme. Door and window hardware, wall paneling, fireplaces and flooring were neither antique nor expensively executed at the time of their construction but are characteristic of Edwardian tastes and irreplaceable today.

Figure 2. Entrance Hall, Room 102.

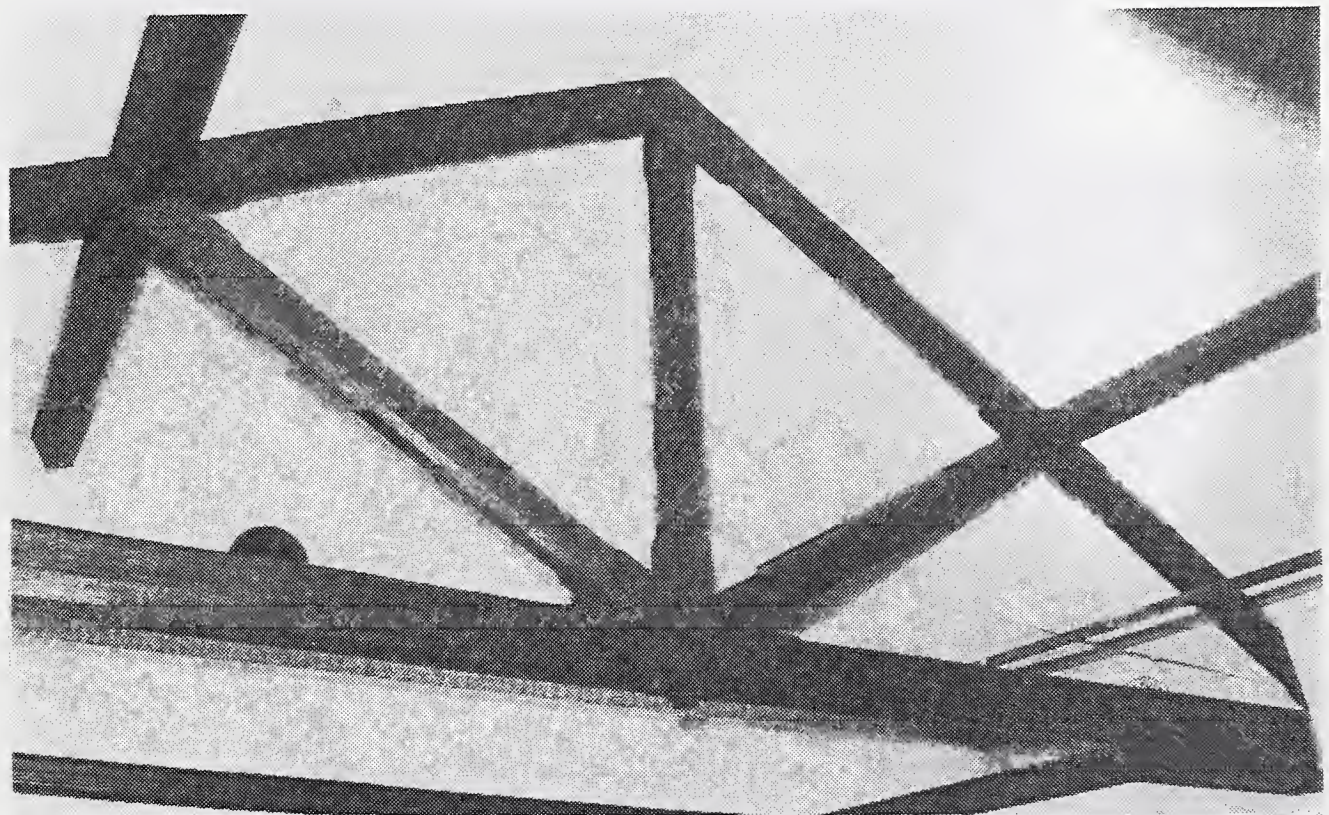
Roofs. The roofs at the original half of the mansion are supported by 2x wood rafters. At the north wing, the ridge beam and intermediate exposed purlins are supported by decorative kingpost trusses (Figure 3), even at the central third of the wing where they are hidden above the ceilings of the stairwell and a small office. Similarly, decorative queenpost trusses support the roof at the ballroom. The southern pine truss members are connected together by short "bed-bolts". Although not structurally detrimental, the truss timbers are checked, twisted and warped somewhat, a common feature of southern pine. The roof structure of the service wing could not be directly observed; it would not be uncommon that it is wood framed although the floors in that wing are cast in place concrete beams and slabs.

Figure 3. North Wing Roof Trusses. Note Access Holes for Bedbolt Nuts About One Foot in from Ends of Kingpost.

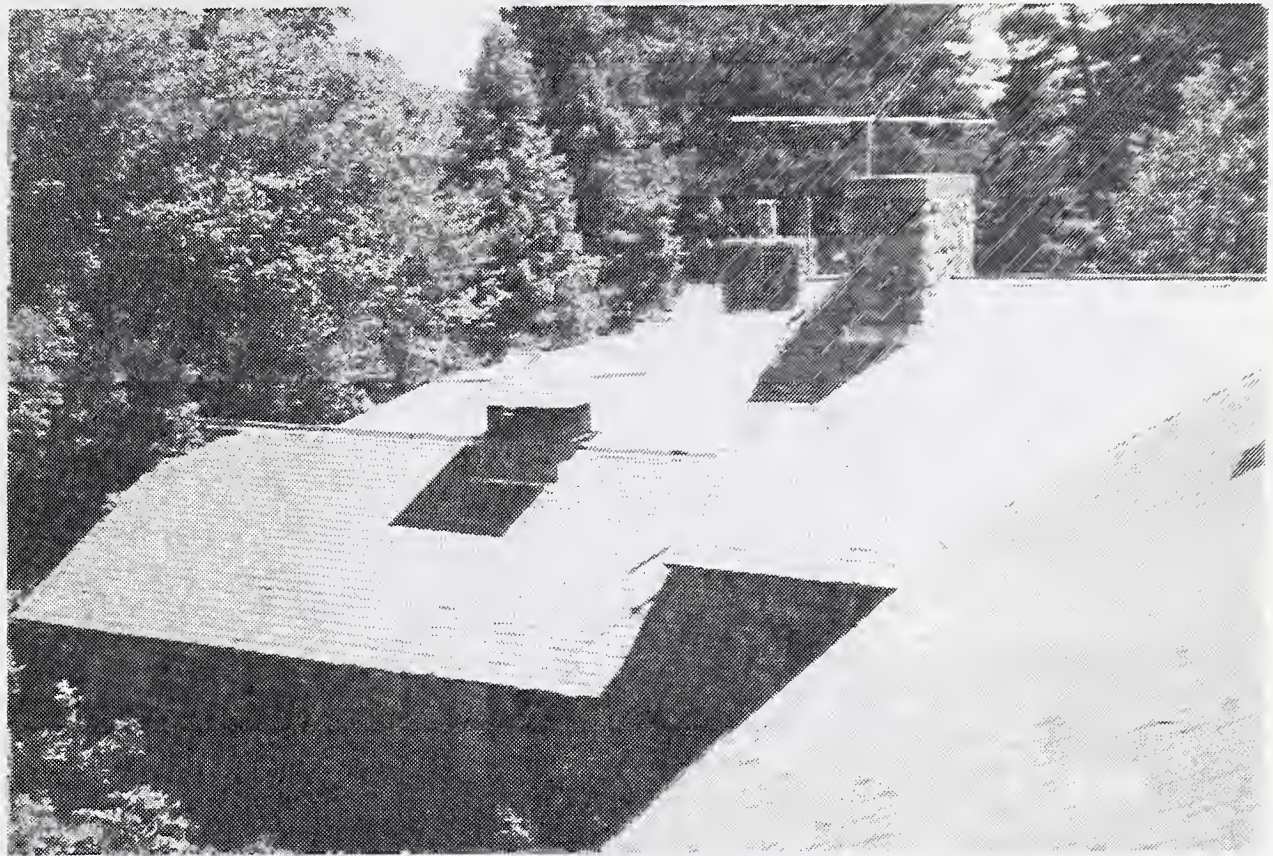
Roofing. The roofs are covered with several types of material (Figure 9): a) red slate over the pitched areas (except for a small section of asphalt shingles at the front entrance); b) tar-and-gravel over the flat area of the service wing, south porch and west patio; c) flat seamed, soldered copper sheet in a flattish

Figure 9. Red Slate Sloping Roofs; Light Colored Flat Seam Copper Roof in Center and Tar-and-Gravel at Back Chimney.

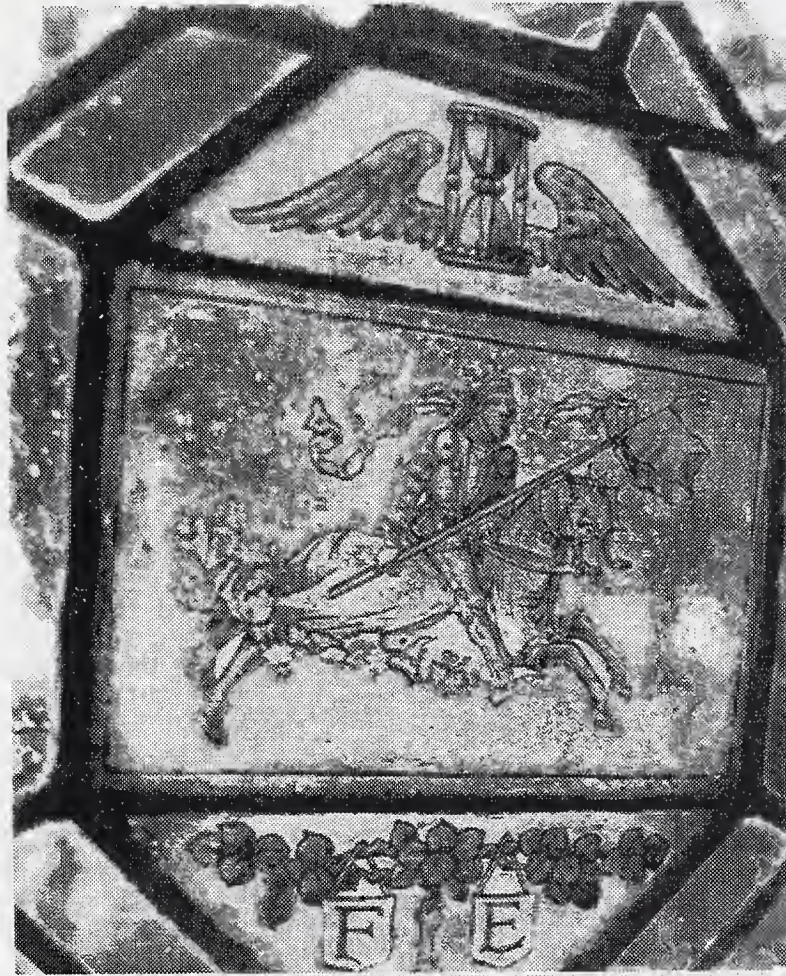
The windows are clear leaded glass set in wood frames, with small painted and stained heraldic glass panels in the center of sash. The panels appear to be early twentieth century work executed in a Medieval Style, complete with antiquing of the exterior surface of the glass to imitate the patina of genuine medieval stained glass (Figures 34A and 34B). The glass and leading appear to be in sound condition except for a few cracked pieces of glass. Needed work is limited to routine repair and painting of the wood sash and frames and replacement of the cracked glass. The replacement of cracked glass should only be done by skilled stained glass restorers. Although some of the painted, leaded lites are protected by external glazing, this should be added at all of the leaded sash for long term protection. Because the heraldic images are painted on the interior surface of the glass, they require special care when the windows are cleaned. While currently sound, this paint can easily be damaged by any aggressive cleaning. They are actually best left uncleaned but can be cleaned if only water and soft cloths are used with no rubbing.

Figure 34A. Stained Glass Panel, Interior Side, Room 106A.

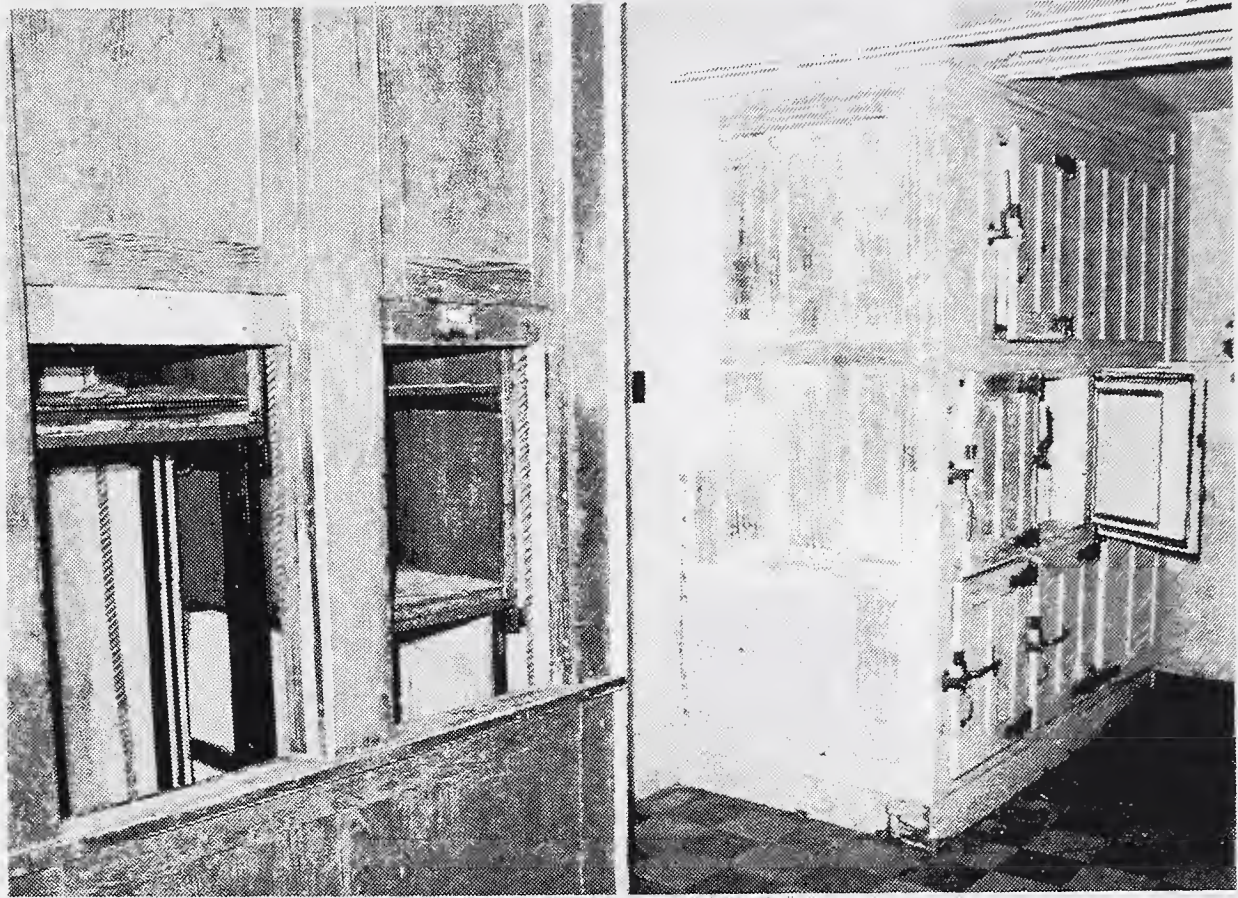
Kitchen Facilities. Descriptions in previous reports of the building suggest that the kitchen facilities are of historic value because they retain early twentieth century appliances intact. In our opinion, most of the appliances and room finishes date from the institutional usage of the building by the state Department of Environmental Management and were probably installed in the 1950's. These spaces and features do not have sufficient integrity to warrant preservation treatment. There are, however, a few individual features such as the dumb waiter and safe in the serving room (room 112) and the built in icebox and pantry shelving (Figure 35) in the room directly below (rooms B03 and B04) that are early elements worthy of retention and preservation.

Figure 35. Dumbwaiter and Ice-Box in Basement.
